Marshalls Creek Floodplain 'man made' obstructions from Wooyung to Brunswick Heads.

> NOTICE OF MOTION 9.4 Lowering Flood Levels in North Byron Floodplain File No: I2017/605 Cr Alan Hunter 25/5/2017

# Hot Spots on the Floodplain

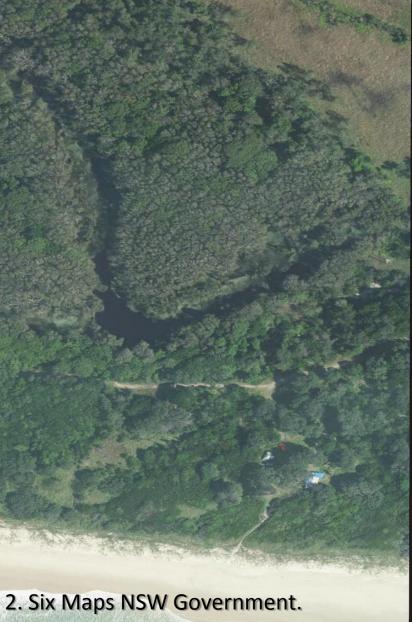
# L1 - Wooyung

## **Outlet closed before 1979**

Source: Mooball Crabbes Creek Drainage Trust District Plan
