# **CASE STUDY Facts ... North Byron Shire Flood Mitigation Project for Cr David Warth**

# **Community-based Consultation**

Identifying the natural flood outlets along the coastline between Wooyung and the mouth of the Brunswick River at Brunswick Heads.

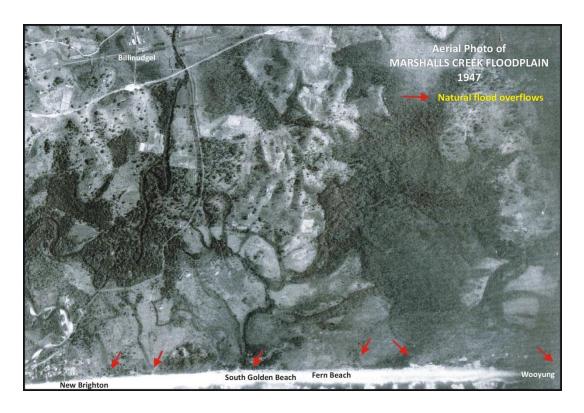
#### **Observation 1:**

1947 aerial photo showing a number of natural floodwater flow channels to the ocean.

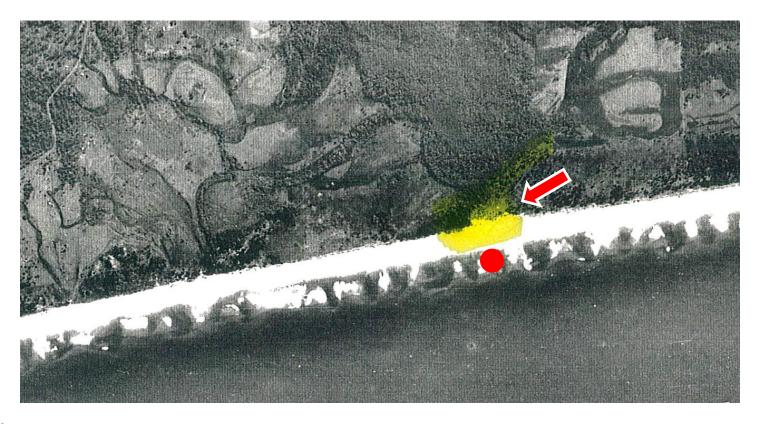
# **Observation 2:**

1947 yellow area showing location of the outlet just north of Fern Beach.

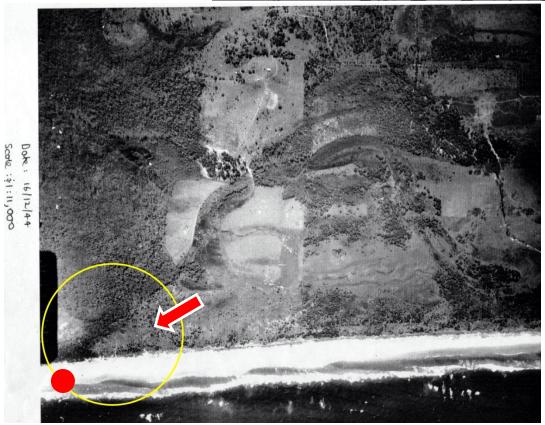
# **Observation 3:**

Additional proof identification of North Ocean Shores flood outlet 1944.

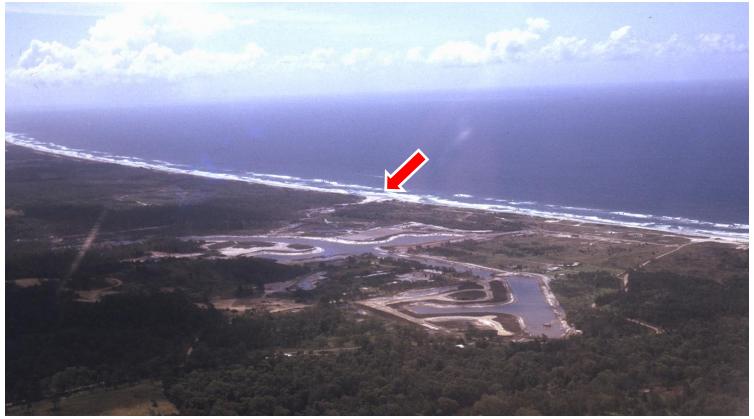
**Observation 4:**

Circa 1974 Development of Stage 2 North Ocean Shores showing outlet open and flowing.

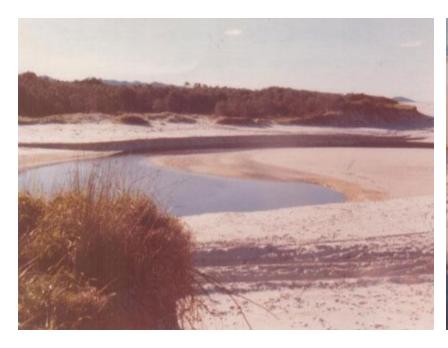
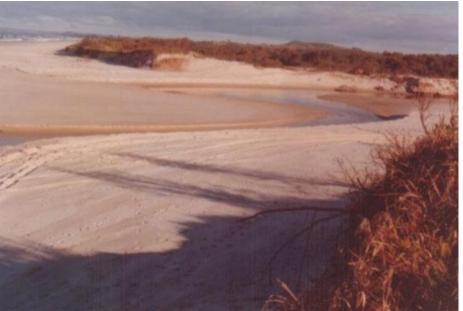
#### **Observation 5:**

1974 Development of Stage 2 North Ocean Shores showing outlet open and flowing.

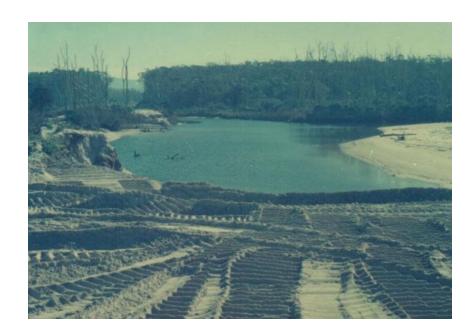
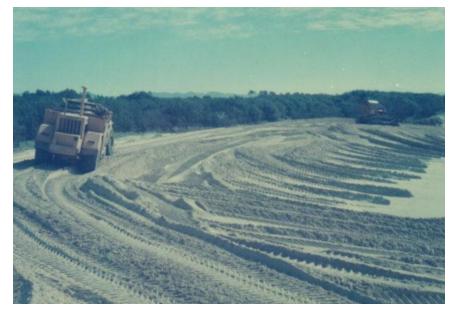
# **Observation 6:**

1976 North Ocean Shores **outlet closed** and **dune stabilisation** undertaken at the outlet mouth. (see slide 13 - Deputy Premier's letter to Council 1982)

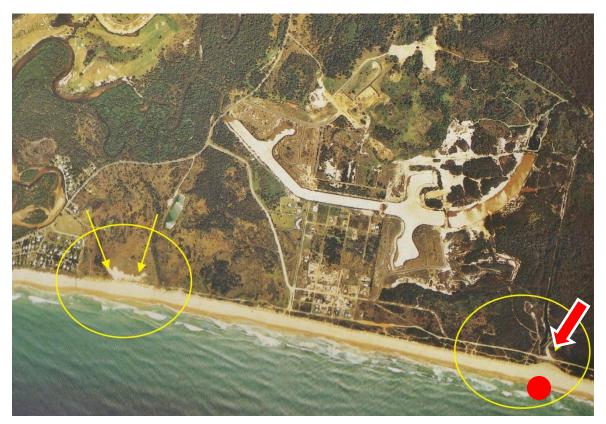
#### **Observation 7:**

1980 North Ocean Shores Outlet closed.

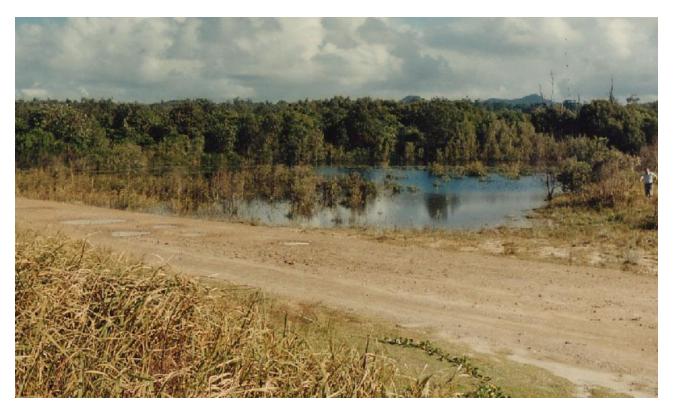
**Observation 8:**

1987 Outlet still closed.

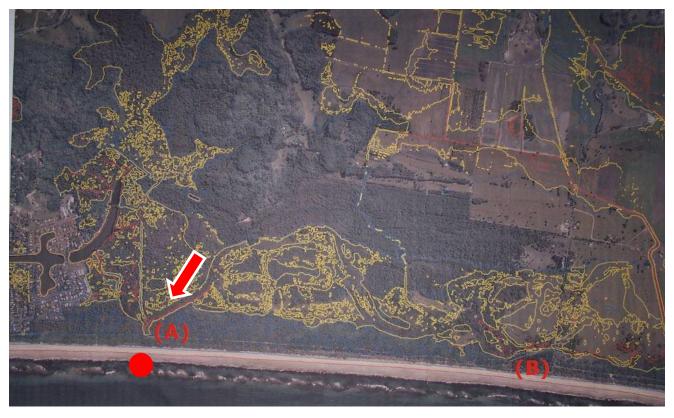
# **Observation 9:**

2007 Topographic map of land showing AHD levels around the outlet (A) at North Ocean Shores.

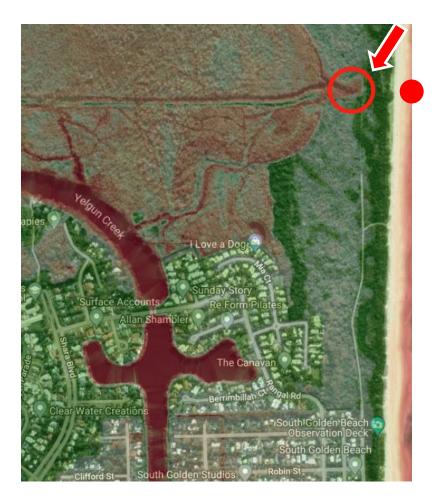
# Location 3:

Billinudgel Nature Reserve north of Fern Beach (153.5506, - 28.4856)

- 1. Low elevation (around 1.2m/1.3 AHD), hence will be an area that will be inundated early in a flood event.
- 2. Still have semi-intact remnant drainage channels that will carry floodwater from overflow from Marshalls Creek or Billinudgel Nature Reserve.
- 3. Are located on Crown Land.

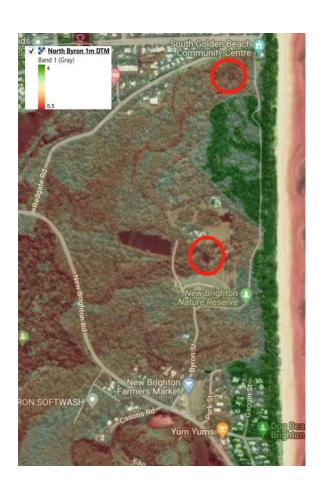
# Location 1 and 2:

- 1. North of sports field at New Brighton (153.5491, -28.5037)
- 2. South of levee at SGB (154.5499, -28.4984)

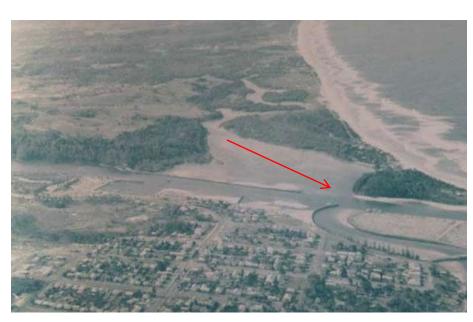
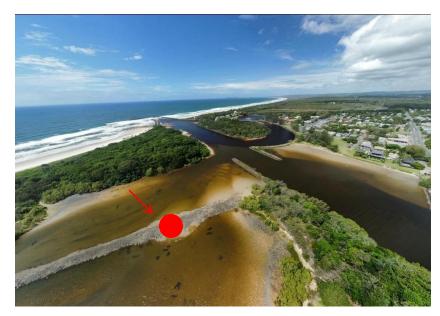
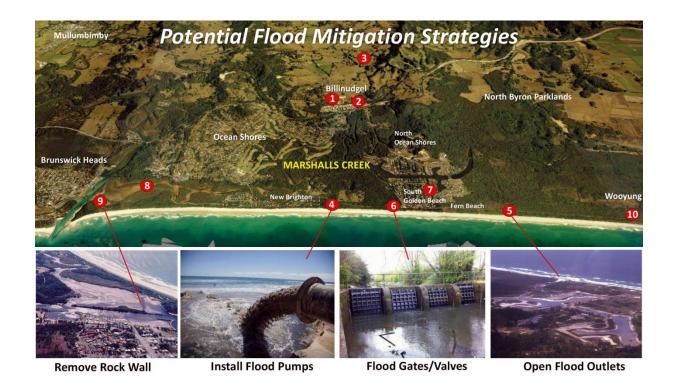
# **Readings Bay Rock Wall Obstruction**

Now blocked
